SUBJ: Resource Conservation and Recovery Act Compliance Evaluation Inspection (CEI)  
Acrospace Coatings International, LLC  
EPA ID # ALR000026872

SUBJ: Resource Conservation and Recovery Act (RCRA) Compliance Evaluation Inspection (CEI)  
Aerospace Coatings International, LLC  
EPA ID Number: ALR000026872

Aerospace Coatings International, LLC (ACI) in Oxford, Alabama, is an aircraft maintenance, repair and overhaul repair facility that specializes in hydraulic, pneumatic and landing gear part repair.

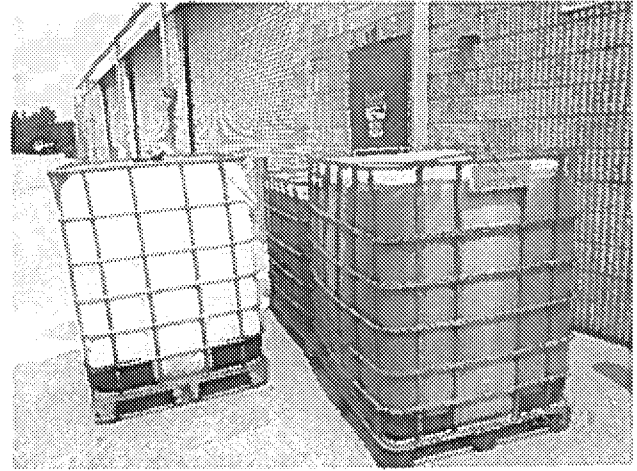
In addition, the inspectors observed a 330-gallon tote of Zyglo, two 330-gallon totes of nickel solution and one 220-gallon tote of hydrochloric acid being stored as product for reuse (Pictures 4-5). These containers were moved outside temporarily for the hazardous waste chromic acid totes to be staged. During the inspection, the four totes of product for reuse were moved back inside to the staging area.

Picture 4 – Staging Area process materials for reuse

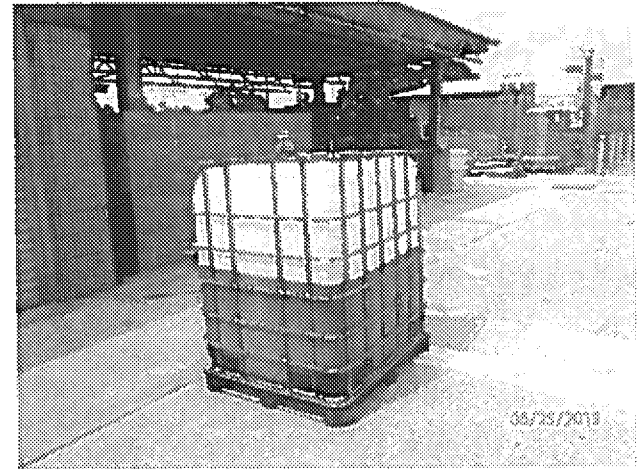
Picture 5 – Staging Area process materials for reuse

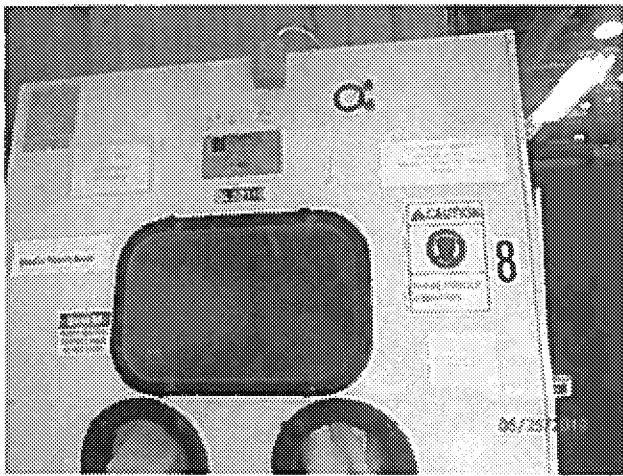
Spent blast media contaminated with cadmium was observed on the floor and the media blaster (Pictures 6-13). Mr. Landingham stated that housekeeping was ongoing and that the personnel assigned to the area would be back to sweep up the spent media.

Picture 7 – Staging Area Media Blaster

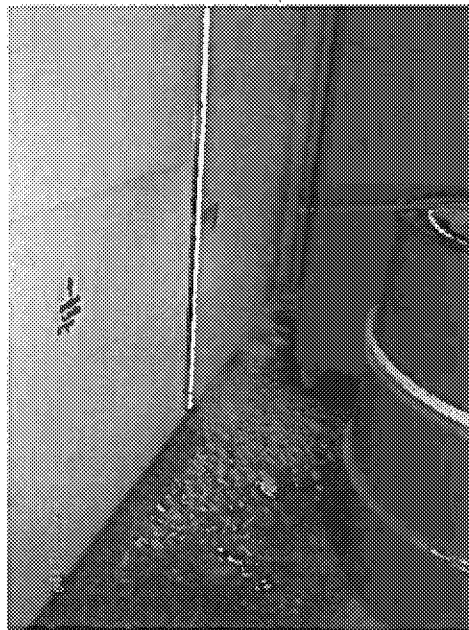
Picture 10 – Staging Area spent blast media on the ground

Pursuant to ADEM Admin. Code r. 335-14-3-.01(7)(a)6. [40 C.F.R. § 262.17(a)(6)], which incorporates ADEM Admin. Code r. 334-14-3-.14(2) [40 C.F.R. § 262.251], and is a condition of the LQG Permit Exemption, a generator is required to maintain and operate its facility to minimize the possibility of a fire, explosion, or any unplanned sudden or non-sudden release of hazardous waste or hazardous waste constituents to air, soil, or surface water which could threaten human health or the environment.

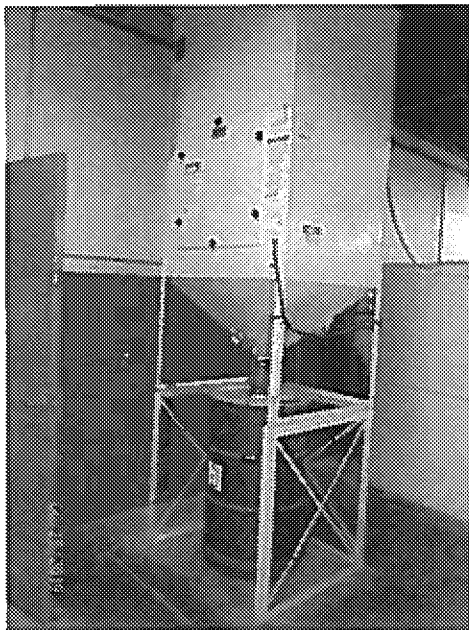
The inspectors returned to the Plating Prep Shop and observed the media blaster and the attached baghouse hopper (Pictures 28-30). The 55-gallon SAA drum underneath the hopper was closed and labeled. No media was observed on the floor. Next to the hopper was a HEPA vacuum that was not labeled and a 55-gallon SAA drum of chromium contaminated debris (Pictures 31-33). Mr. Landingham explained that the HEPA vacuum was used specifically for the media blaster area and currently contained spent blast media. Based on the observations made during the inspection, the HEPA vacuum was a hazardous waste SAA container. The container was not marked or labeled with a hazardous waste label indicating the contents.

Picture 28 -- Plating Prep Shop blaster hopper and drum

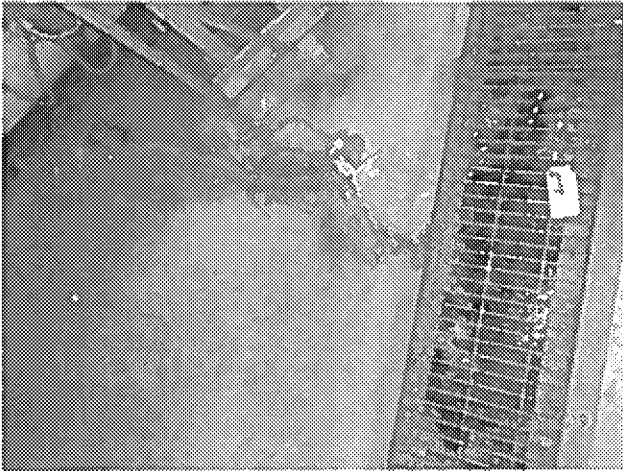
operation at the time of the inspection. The inspectors observed releases of used coolant product under the machinery draining to the floor grate. The inspectors also noted that the floor grate was over half full of used coolant product (hydraulic oil, coolant and water) (Pictures 46-49). The inspectors explained that leaving the used coolant product in the floor grate was storage and the used coolant product needed to be cleaned out of the floor grate.

Picture 42 – OD Shop released hydraulic oil in floor grate

Pursuant to ADEM Admin. Code r. 335-14-3-.01(7)(a)2. [40 C.F.R. § 262.17(a)(2)], which incorporates ADEM Admin. Code r. 335-14-6-.10 [40 C.F.R. Part 265, Subpart J], and is a condition of the LQG Permit Exemption, a generator accumulating hazardous waste in tank systems is required to comply with the applicable requirements of ADEM Admin. Code r. 335-14-6-.10 [40 C.F.R. Part 265, Subpart J], except ADEM Admin. Code r. 335-14-6-.10(8) [40 C.F.R § 265.197(c)] (closure and post-closure care) and ADEM Admin. Code r. 335-14-6-.10(11) [40 C.F.R § 265.200] (waste analysis and trial tests).

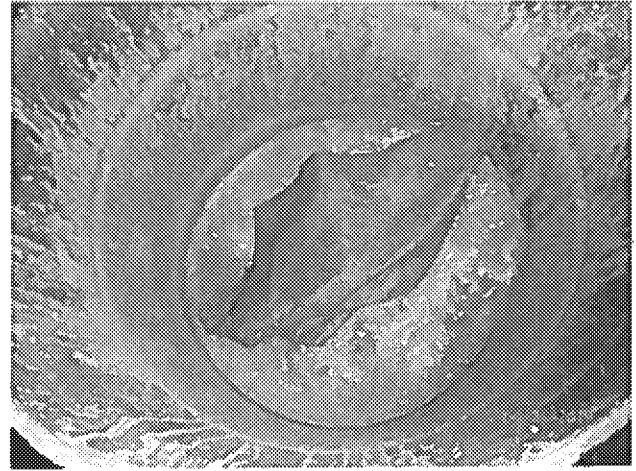
The OD Shop provides machining for the outer diameter of small aircraft parts. The inspectors observed a 55-gallon SAA drum of hazardous coolant sludge on a portable secondary containment (Pictures 35, 36, 39). The drum exterior and secondary containment was covered in coolant sludge. A second 55-gallon SAA drum of hazardous coolant sludge also had coolant sludge on the drum exterior (Pictures 43-45).

Picture 45 – OD Shop HW coolant sludge

Pursuant to ADEM Admin. Code r. 335-14-3-.01(7)(a)6. [40 C.F.R. § 262.17(a)(6)], which incorporates ADEM Admin. Code r. 334-14-3-.14(2) [40 C.F.R. § 262.251], and is a condition of the LQG Permit Exemption, a generator is required to maintain and operate its facility to minimize the possibility of a fire, explosion, or any unplanned sudden or non-sudden release of hazardous waste or hazardous waste constituents to air, soil, or surface water which could threaten human health or the environment.

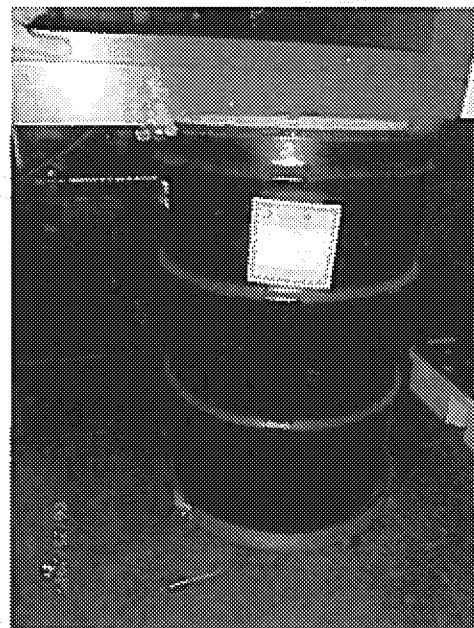
The Shot Peen media blaster was in the OD Shop. This media blaster was self-contained, and no spent media was observed on the floor. However, the 5-gallon SAA container used to capture the spent blast media was not labeled, but the 55-gallon SAA drum of spent blast media from the Shot Peen media blaster was labeled as hazardous waste (Pictures 50-53).

Picture 52 - OD Shop Shot Peen spent blast media

Pursuant to ADEM Admin. Code r. 335-14-3-.01(5)(a)5 [40 C.F.R. § 262.15(a)(5)], which is a condition of the SAA Permit Exemption, a generator is required to mark or label its containers (i) with the words "Hazardous Waste" and (ii) with an indication of the hazards of the
